TURKMENISTAN'S PRISON SYSTEM

Satellite Images Show What the Turkmen Government Will Not

Published by: Crude Accountability

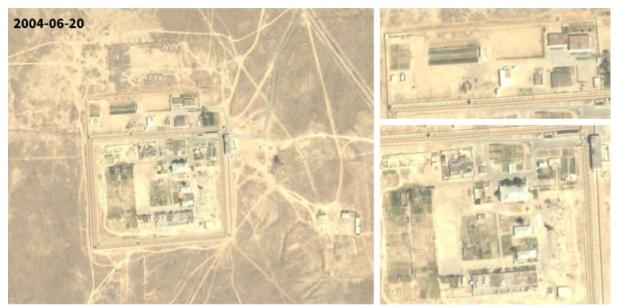
Fig. 2 High resolution imagery of the Akdash prison site, dated June 2004. Imagery shows the Old Akdash compound.

The earliest satellite image of the site included in this report is dated June 2004, acting as a useful baseline image taken prior to the rapid development of the 2010s.

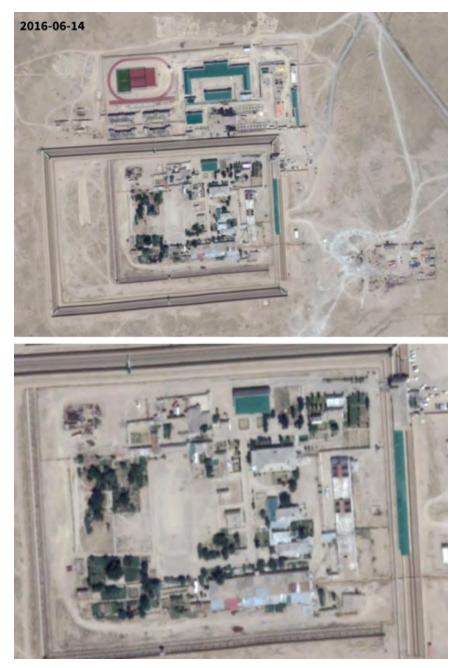
Fig. 3 High resolution imagery of the Akdash prison site, dated June 14, 2016. Construction of the new perimeter wall is almost complete.

High resolution imagery dated July 2013, just prior to construction of the 'New Akdash' site, shows efforts to enlarge the compound at Old Akdash through expansion of its perimeter wall, as well as construction of what Crude Accountability refers to as a second prison building, which features 8 "open air cells." By June 2016, when the next batch of satellite imagery was captured, the expanded perimeter wall had been finished, and small-scale expansion of infrastructure within this perimeter was visible. Obtaining imagery from 2016 was requested in response to reports from Crude Accountability contacts that active development at the Akdash prison site was ongoing from 2014; satellite imagery corroborated these reports.

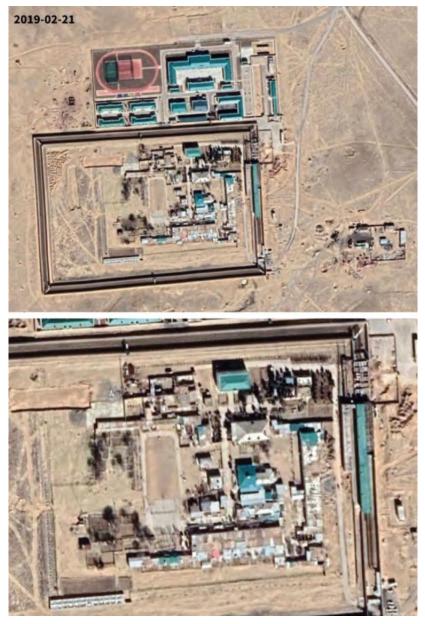
Fig. 4 High resolution image from Google Earth, dated February 21, 2019. Imagery shows the construction of New Akdash and infrastructure within the perimeter wall of Old Akdash

High resolution imagery from Google Earth, dated February 2019, revealed that the main checkpoint building of Old Akdash had been demolished and rebuilt to connect the complex to New Akdash, which shares walls and supporting infrastructure with Old Akdash. Further small scale infrastructure expansion, particularly in the areas surrounding the checkpoint building, continued, and the previously "open air cells" have now been covered with a roof.

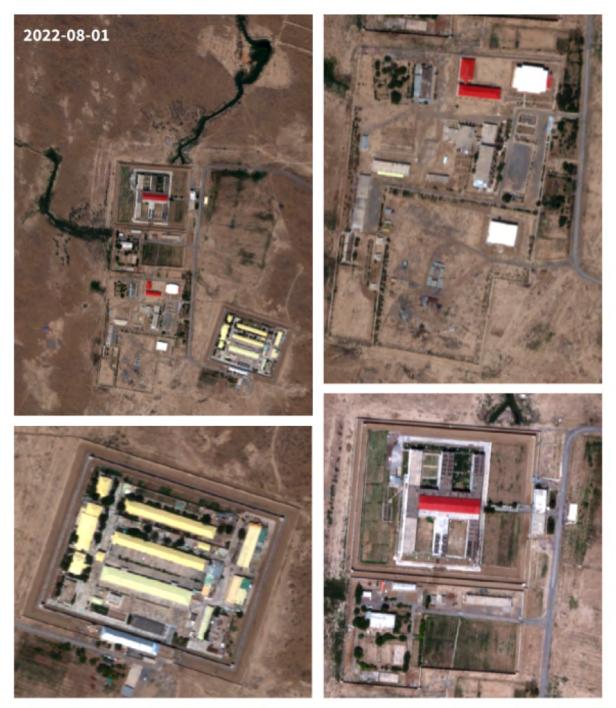
Fig. 5 High resolution imagery obtained from Planet SkySat satelHtes, dated 1 August 2022.

Since 2020, satellite imagery has shown little activity at the Old Akdash site, apart from continued construction of small buildings within its perimeter, and the expansion of cultivated land along the southern and eastern edges of the perimeter. The most recent satellite image obtained of Old Akdash is dated August 1, 2022, and was captured by Omanos Analytics using Planet SkySat satellites; it was taken with a resolution of about 60 cm. This expansion of cultivated land, visible in the aforementioned high resolution image, confirms that the facility at Old Akdash is still in use as of mid-2022.

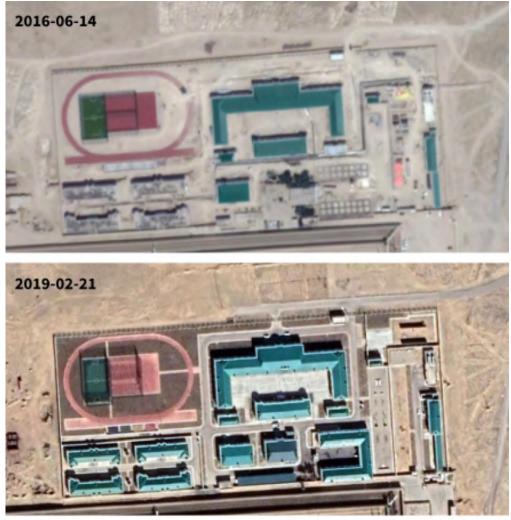
Fig. 6 New Akdash, constructed next to Old Akdash in June 2016, and appearing to be complete in early 2019.

Satellite imagery dated February 2019 indicates that construction at New Akdash was largely completed. Between early 2019 and late 2021, multiple high resolution images were available; these images showed little evidence of change at the New Akdash site, apart from vehicles being located in different positions between images. However, an area of cultivated land located just outside the perimeter wall of the site appears to have been in active use throughout 2019-2021.

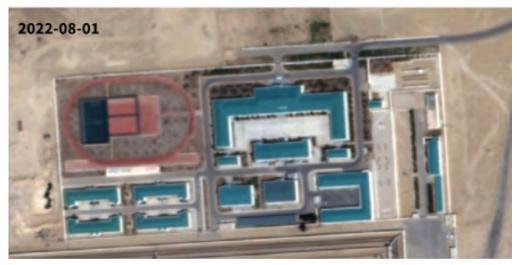
Fig. 7 High resolution imagery from Planet SkySat satellites dated August 1, 2022. No further development is visible in August 2022.

The most contemporary satellite image obtained of New Akdash is dated August 1, 2022, and was captured by Omanos Analytics using Planet SkySat satellites; it was taken with a resolution of about 60 cm. This imagery continued to show little evidence of development at the sites, lending further credence to reports received by Crude Accountability that the facility at New Akdash is not yet fully operational, owing to financial instability within Turkmenistan connected to the COVID-19 pandemic, among other factors.

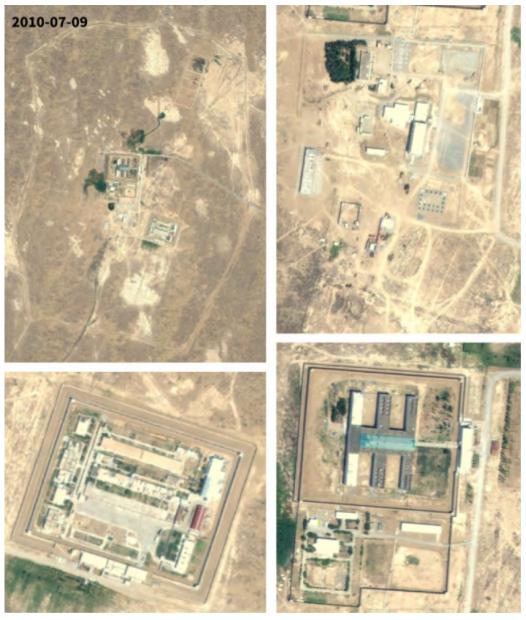
Fig. 8 High resolution imagery of Ovadan Depe from Google Earth dated July 2010. Top left panel shows the whole site, including the outer perimeter "control strip." Top right panel shows a close up of the construction area within the site. Bottom left shows the southern compound of Ovadan Depe. Bottom right shows the northern compound of Ovadan Depe.

High resolution imagery, taken from Google Earth and dated July 2010, shows the original facilities of Ovadan Depe, consisting of two main prison compounds, both with high double perimeter walls with guard towers on each corner.

A third walled area, connected to the northernmost of these compounds, appears to be for prison and security personnel, given the presence of what is seemingly a garage/storage area, as well as the comparatively lax security (single layered perimeter wall). High resolution imagery shows active construction ongoing in an area just west of Ovadan Depe's southernmost compound (the 'active construction site'), as well as a trench encircling the Ovadan Depe site (~0.5 to 1 km from the walled compounds). Crude Accountability contacts referred to this as the outer "control strip" perimeter of the complex. Between 2010 and 2012, little change was visible within the Ovadan Depe complex apart from evidence of continued development within the active construction site, where the foundations for 3-4 buildings were added.

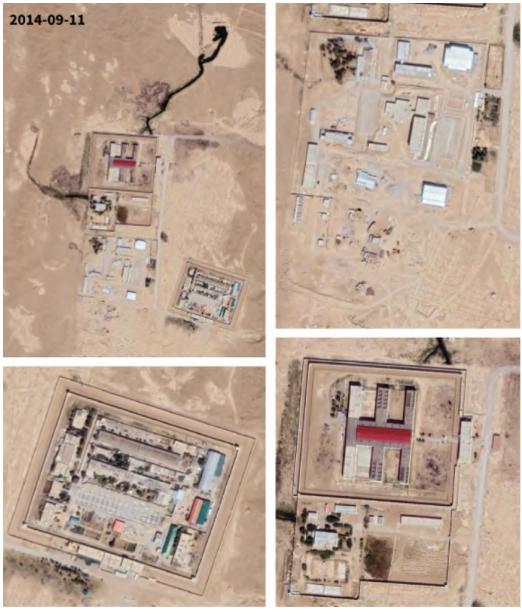
Fig. 9 High resolution imagery of Ovadan Depe from Google Earth dated September 2014. Top left panel shows the facilities within the site perimeter. Top right panel shows a close-up of the construction area within the site. Bottom left shows the southern compound of Ovadan Depe, bottom right shows the northern compound of Ovadan Depe.

The next batch of imagery, gathered from Google Earth and dated September 2014, marks a period of active expansion. We chose this time frame in response to reports received from Crude Accountability contacts regarding rapid development on the Ovadan Depe prison site. These reports of rapid development were substantiated by satellite imagery, which shows the two main prison compounds at Ovadan Depe under active expansion throughout 2014. The foundation for a third large building within the southern compound was added (see bottom left panel below, Figure 9), with approximately the same dimensions as the two existing main buildings within the complex. Given that there are walls surrounding these main buildings, these are likely for prisoner accommodation; the completion of the third large building could increase the capacity of the compound by up to 50%. While there were no visible additions made to the buildings within the northern compound, the expansion of a drainage/wastewater channel outside of its perimeter may indicate an increase in prison capacity, although Ovadan Depe, as far as the campaign is aware, has never been filled to capacity.

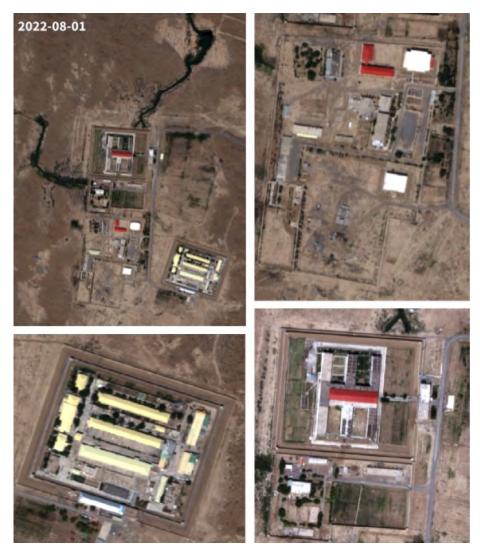
Fig. 10 High resolution imagery from Planet SkySat satellites dated August 2022. Top left panel shows the facilities within the site perimeter. Top right panel shows a close-up of the construction area within the site. Bottom left shows the southern compound of Ovadan Depe, bottom right shows the northern compound of Ovadan Depe.

New buildings located in the area south of the main complex at Ovadan Depe were visible in imagery from 2018 obtained by the Prove They Are Alive! campaign. The lack of heavy duty walls surrounding these buildings indicates that they are not used for prisoner accommodation, and may rather be used for prisoner visitation. As of 2014, there were reports of visitation at Ovadan in the old prison, which continued, including for previously disappeared prisoners accused of Islamic extremism. Imagery from Bing Maps, dated September 2021, was obtained by Omanos Analytics, who utilized imagery from the Sentinel 2 satellite to accurately date the Bing Maps image. Also obtained by Omanos Analytics was satellite imagery of Ovadan Depe dated August 1, 2022, captured using Planet SkySat satellites; it was taken with a resolution of about 60 cm. These images showed evidence of continued resurfacing and maintenance work, as well as the completion of the projects undertaken between 2012 and 2014 on site. Couple this with continued use of cultivated land, as well as the movement of vehicles between recent images taken of the site, and it can be stated with confidence that Ovadan Depe prison is still in use.

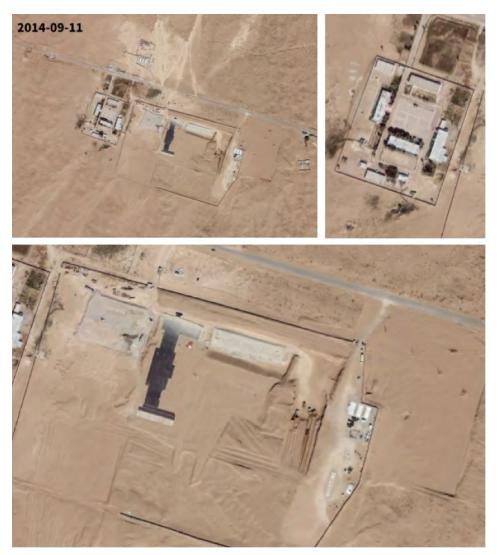
Fig. 11 High resolution imagery from Google Earth dated September 2014. Top left panel shows the area of the unknown site. Top right panel shows a close-up of the small compound originally alone on the site. Bottom panel shows a close-up of the construction on the site.

High resolution imagery dated September 2014 shows initial construction underway at the Unknown Site, which is consistent with reports received by Crude Accountability that construction on 'New Ovadan' began the same year. Further high resolution imagery, dated September 2017, shows a large perimeter wall constructed on site; the buildings within this wall were at varying stages of completion. Imagery captured in October 2018 was helpful in tracking the pace and scale of development on site during a period of high activity. By this time, roofs were in place on most buildings, however one building towards the southeast of the compound remained partially roofed throughout 2018. It is unclear whether this was due to incomplete construction, or if these were intended to be "open air cells." One building located in the southeastern corner of the compound appears to have a ramp leading underground, suggesting further underground facilities at the site.

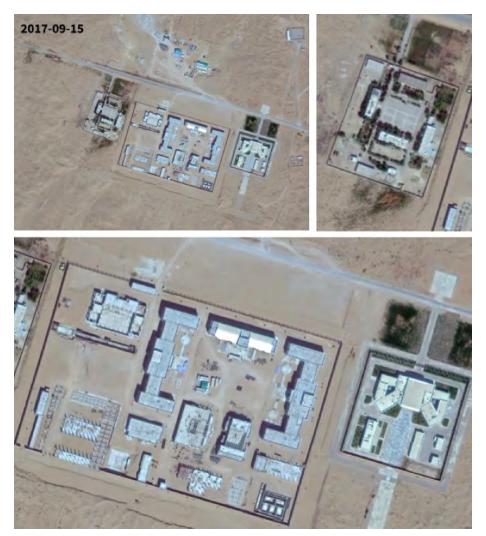
Fig. 12 High resolution imagery from Google Earth dated September 2017. Top left panel shows the area of the unknown site. Top right panel shows a close-up of the small compound originally alone on the site. Bottom panel shows a close-up of the construction on the site.

The compound appears to have four guard towers, and its single layered perimeter wall is made of solid concrete on three sides; the road-facing side of the perimeter wall appears to be semi-transparent. A further walled compound is also visible at the site, located on the eastern edge of the main compound. This compound has a single-layer perimeter wall containing a large main building and four smaller buildings. Within this smaller compound, there is well maintained vegetation, and the road-facing wall also appears to be semi-transparent and even decorative.

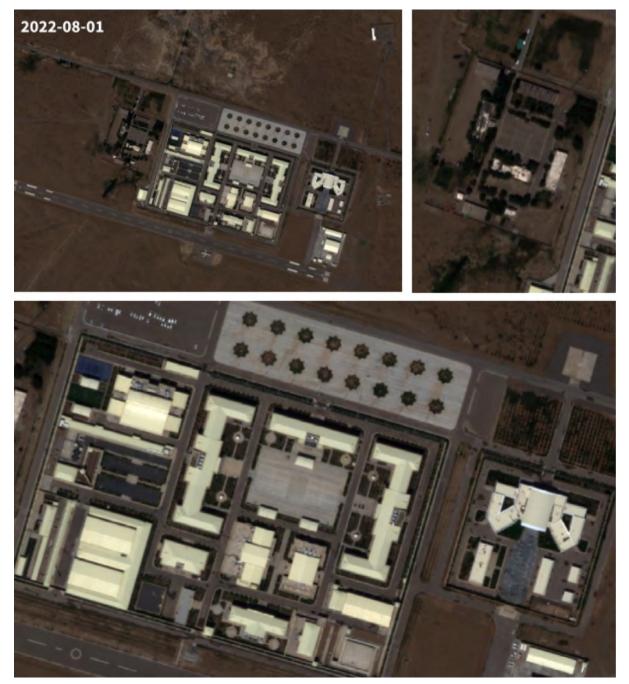
Fig. 13 High resolution imagery from Planet SkySat satellites dated August 2022. Top left panel shows the area of the unknown site and appears to be in use, including a plane and landing strip visible. Top right panel shows a close-up of the small compound originally alone on the site. Bottom panel shows a close-up of the construction on the site.

Satellite imagery of the Unknown Site, dated August 1, 2022 and captured using Planet SkySat satellites, appears to indicate that construction on site is completed. In total, the compound consists of about 15 buildings. Most of the buildings have large silver features on their roofs, some appearing to be pipework, indicating that they are likely ventilation systems. Akin to the smaller compound, the main compound is planted with well-maintained vegetation. Towards the road-facing north perimeter wall are outdoor sports facilities, with structures surrounding them that may serve as spectator seating. A large parking lot near the entrance to the compound is also in use, containing some 40 vehicles at the time of image capture. Satellite imagery from 2022 also confirms the construction of a small runway on site. This contemporary imagery was vital, given that since the pandemic, it has become especially difficult for Crude Accountability contacts to gather any information about this Unknown Site.

The jet that is visible in the satellite imagery (see Figure 13, top-left panel, and Figure 16) may be inoperable. In close inspection of the aircraft, it appears that the horizontal stabilizer and the elevators, which control the pitch of the aircraft, are missing. This would mean the aircraft would have incredible difficulty, if even possible, controlling its altitude or even getting off the ground. The aircraft, therefore, is likely inoperable and is possibly a fake/decoy. This further suggests the purpose of the airstrip as a drone base.

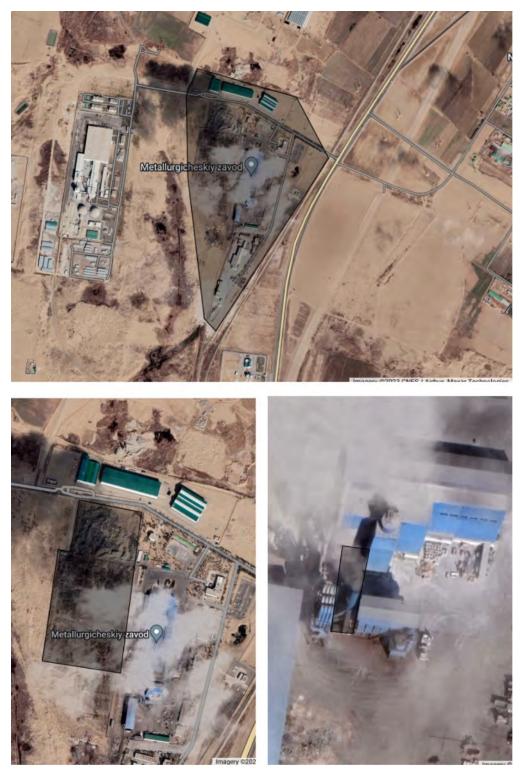
Fig. 14 High resolution imagery from CNES Airbus Maxar dated August 2023. Top panel shows the area of the Turkmen Demir Onumleri factory. Bottom left panel highlights the outdoor storage facility of the factory. Bottom right panel highlights an exhaust/ventilation system.

When we compare the images of the unknown site with images of the already existing metallurgy plant in Turkmenistan, Turkmendemironumleri, which is located a few kilometers south of the Unknown Site, there are immediate differences. The existing plant has an open storage area that looks as though it holds metals. This feature is missing from the Unknown Site in the satellite imagery. The existing plant also contains exhaust pipes, which are a necessity for heat intensive processes associated with metalurgy. This feature is missing from the Unknown site. Finally, the unknown Site contains vast plaza-like areas, garden areas, and a jet-strip with a hangar. These features are inconsistent with the features of Turkmendemironumleri's existing metallurgy plant.

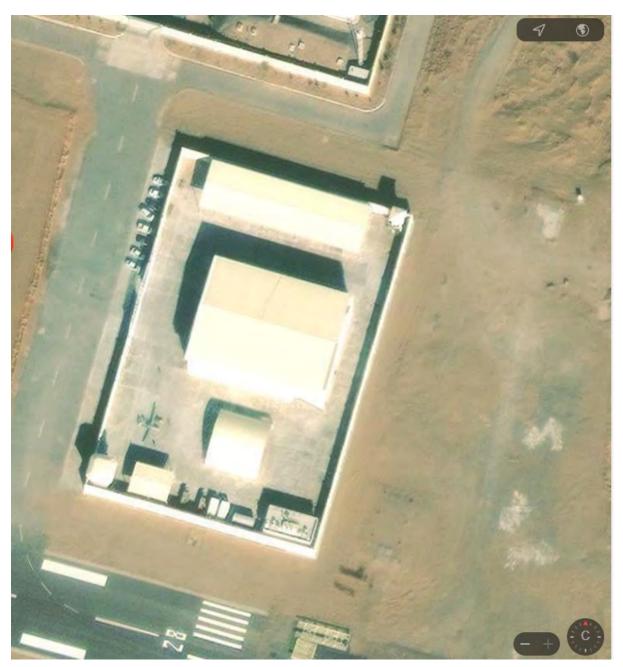
Fig. 15 Runway strip with a parked drone, Apple Satellite Image.

While the airstrip appears at first look to be an oddity, closer inspection illustrates the actual purpose of the runway and adjunct facilities. At the very end of the runway, next to what is believed to be a hanger, is a drone (see Figure 15). The presence of this UAV indicates that the airstrip is a drone base. It is likely that this drone base serves the entire area around Ovadan Depe and is purposed with tracking prisoners who might attempt to escape or individuals trying to enter the security perimeter of the prison. The base may also provide surveillance for other strategic objects, including military-related, and warehouses located north of the Ovadan Depe prison area.

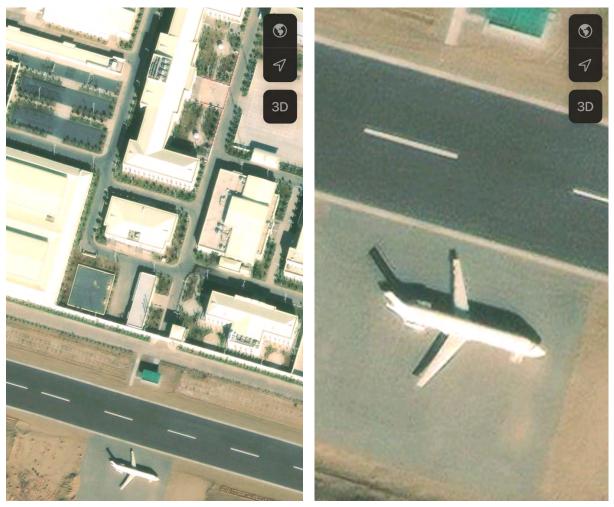
Fig. 16 Apple satellite images obtained October 2023. Zoomed in photo of airplane.
